ASCOTT PARK : 2018-20

Excavations on a 17th century manor house site at Stadhampton, Oxfordshire

PROGRESS SUMMARY 2018 AND PROPOSALS FOR 2019

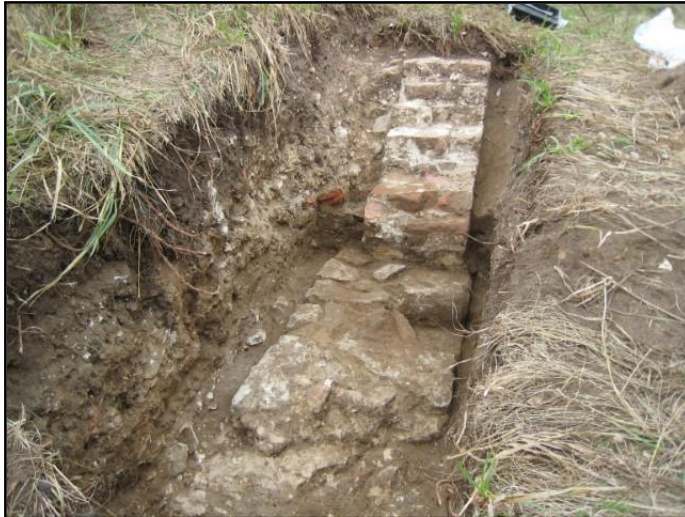
- The terrace retaining walls [**Fig 1**] are of brick on a limestone foundation (as previously found by Dix). The foundations appear to have survived largely undisturbed and significant brickwork remains along the northeast section and towards the southwest end. The terrace overall width is 10.1m (33ft or 2 poles) and the length appears to be c.59.4m (c.195ft or just under 12 poles) giving a length/width ratio of very nearly 6:1. The retaining walls are confirmed as generally 1½ bricks thick (c.14in or 0.35m) on a c.18in (0.45m) wide limestone foundation.

Fig 1 The southwest terrace retaining wall on its stone foundation close to the SW corner

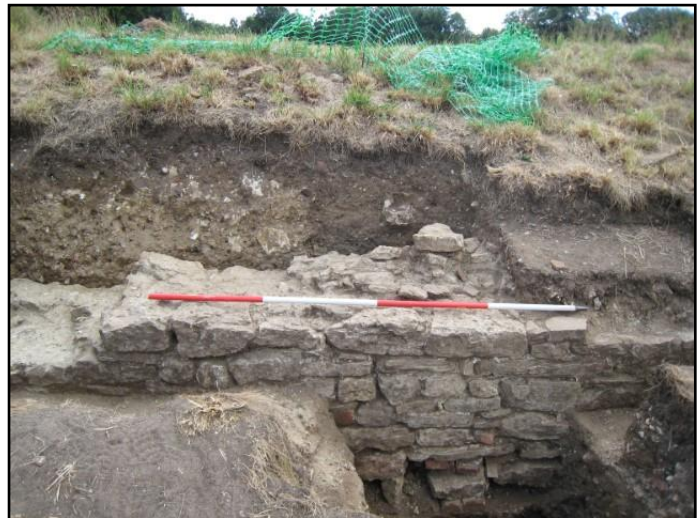
- The house wall [**Fig 2**] on the south side of the basement hollow (as previously found by Everett) is of rough-hewn, randomly-coursed limestone with a rubble core, well dressed on the inside but undressed on the outside facing the side of the hollow. It is 0.85m (2ft 9in) thick and survives towards its eastern end to a height of probably 1.8 – 2.0m.

Fig 2 The south house wall. The deep excavation is on the line of Everett's 1969 trench

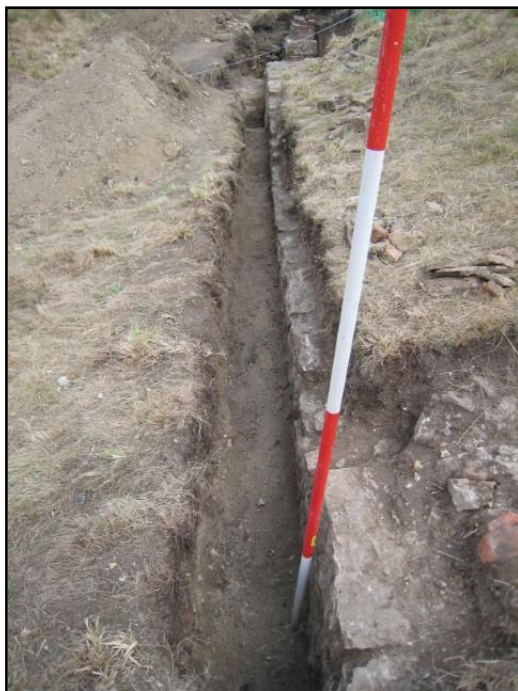
- The unbroken inner face of the south house wall [Fig 3], the upper courses of which we exposed for just over half its length, shows no evidence of internal dividing walls. This provides *prima facie* evidence that the basement was vaulted with the springing being above the surviving masonry, although we cannot yet say what form the vaulting took.

Fig 3 The unbroken inside face of the south house wall, looking east from the estimated mid-point

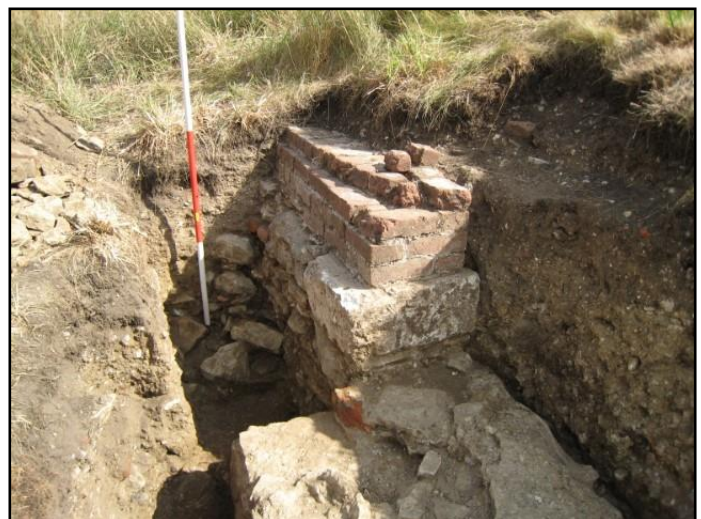
- The NE terrace retaining wall [Fig 4] extends right up to the end of the south house wall and is supported at this point on a deep foundation, the inner (north) face of which has been robbed out exposing a rough core. This foundation being also the retaining wall of the 'annexe' basement, the robbed-out face may possibly be from the demolition of a vault but more work is needed to be certain. If there was an annexed building it must have been built behind the northeast terrace wall, i.e. set back from the line of the house. Equally, the 'annexe' may be an underground extension at cellar level only, or even simply a sunken yard.

Fig 4 The western end of the NE terrace retaining wall where it meets the south house wall
